**BERG RIVER VOËLVLEI AUGMENTATION SCHEME
(BRVAS)**

FACTUAL REPORT

CONTRACT 1A-C-211-01: ADDITIONAL GEOTECHNICAL INVESTIGATION

Report No: 1A-R-211-06 (Rev A)

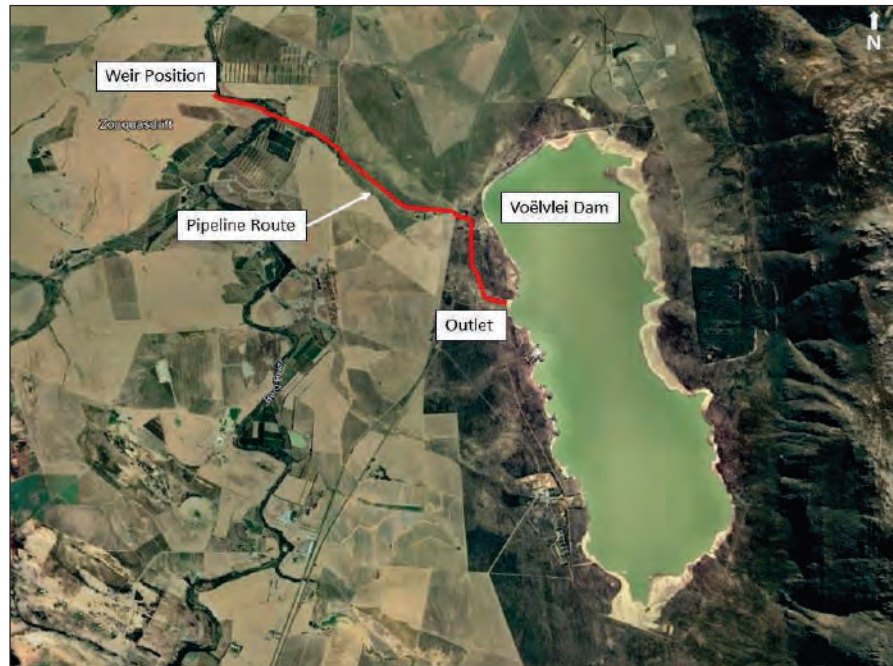
Figure 1: Locality Map

The project is situated in the Western Cape in the Drakenstein Local Municipality of the Cape Winelands District Municipality about 30 km North East of Malmesbury. The weir and the associated structures are located 5 km North West of the Voëlvlei Dam. The pipeline route traverses towards the south east approximately 6.3 km from the pump station to the existing Voëlvlei Dam. Figure 1 below shows the proposed pipeline route.

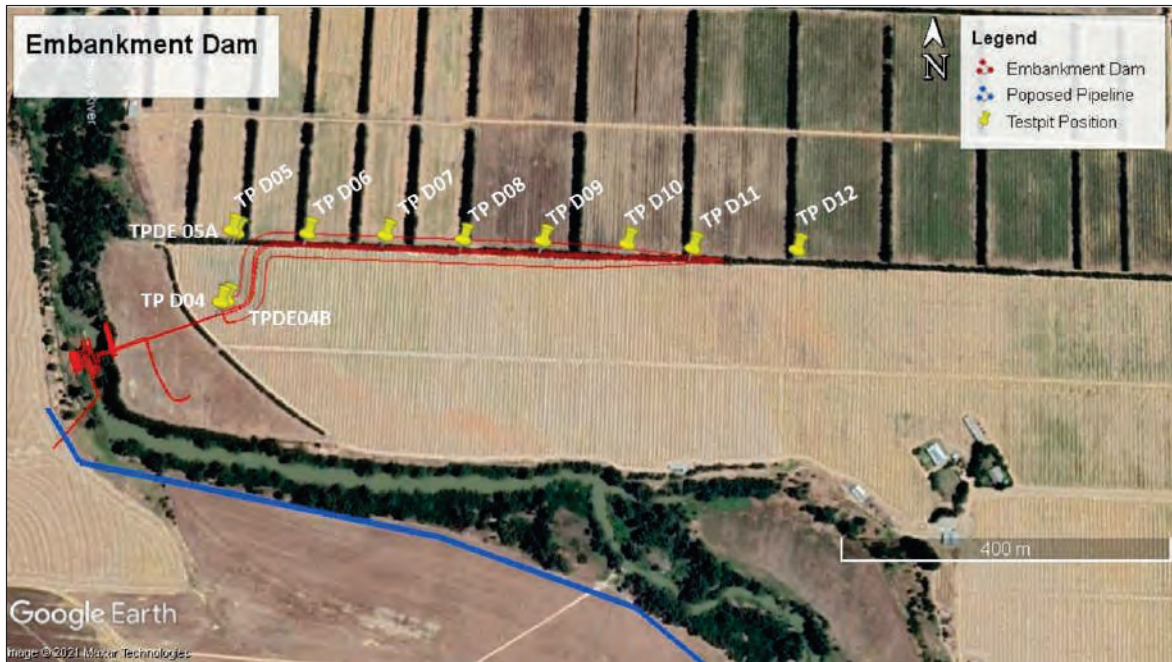
Figure 7: Embankment Testpit Positions

A total of eight (8) test pits (PT D04 to TP D12) were excavated along the proposed earth embankment with a TLB. When the excavator was available on site it was deemed necessary to excavate two (2) more testpits (TPDE 04 B and TPDE 05A) with an excavator as some of the testpits did not refuse with a TLB. Table 2 below indicates the test pits excavated at the proposed embankment wall showing the depth to bedrock and test pit end depth. Figure 7 shows the location of the testpits along the proposed embankment.

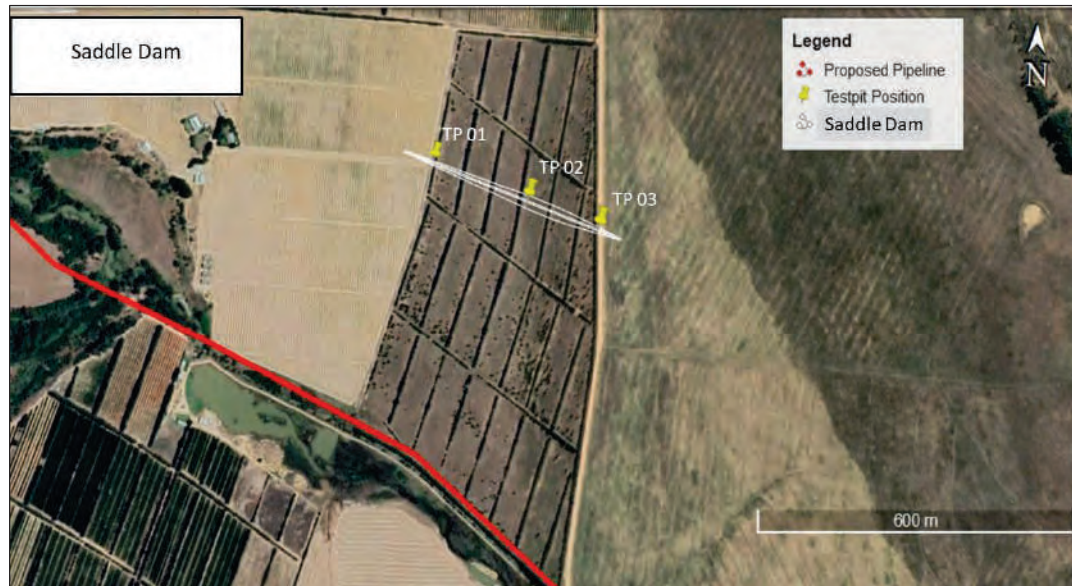
Figure 8: Saddle Dam Testpit Positions

A total of three (3) test pits (PTE 01 to TPE 03) were excavated at the proposed saddle dam location. Table 3 below indicates the test pits excavated showing the depth to bedrock and testpit end depth. Figure 8 shows the location of the testpits.

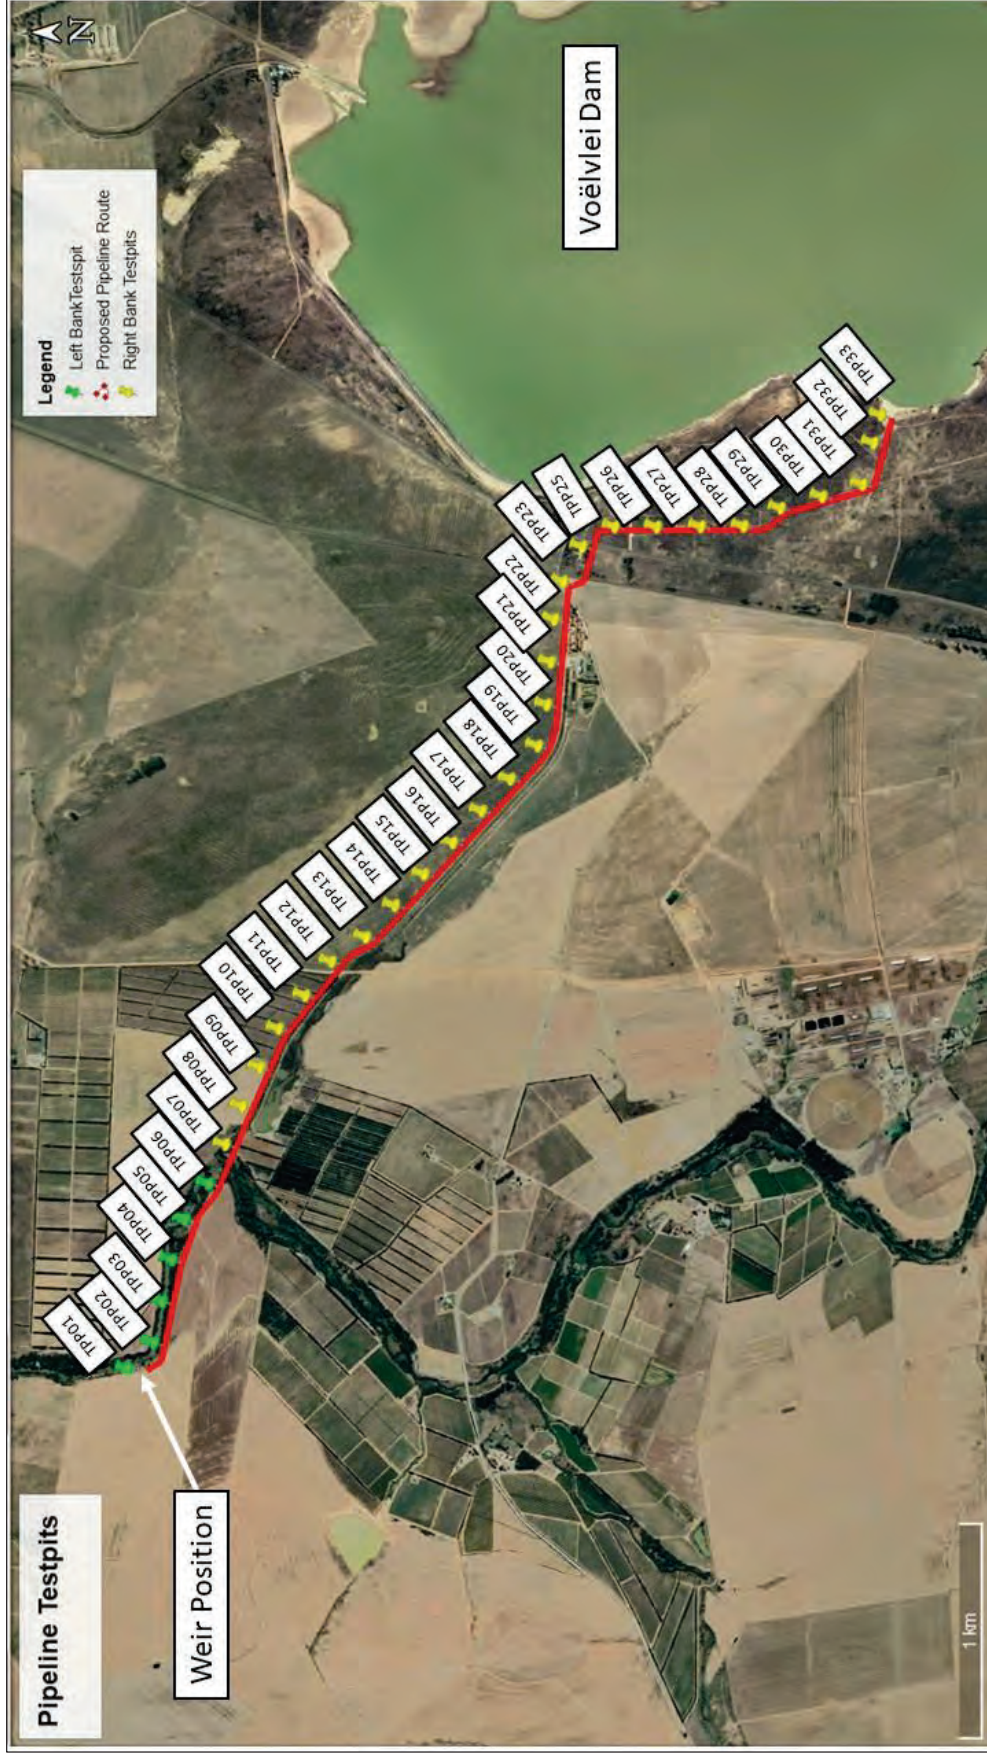
Figure 9: Pipeline Testpit Positions

The proposed pipeline is approximately 6 km long and testpits were excavated at 200 m intervals along the alignment. From the pump station, approximately 1 km of the pipeline traverses along the left bank of the river. After crossing the river, the pipeline alignment runs along the right flank of the current canal. Two of the testpits were close to crossings and it was not deemed necessary to excavate them as the information from the crossing was considered to be sufficient for the pipeline route. A total of 31 testpits were excavated along the proposed pipeline route. Table 4 below shows the testpit coordinates and Figure 9 shows the testpit locations.

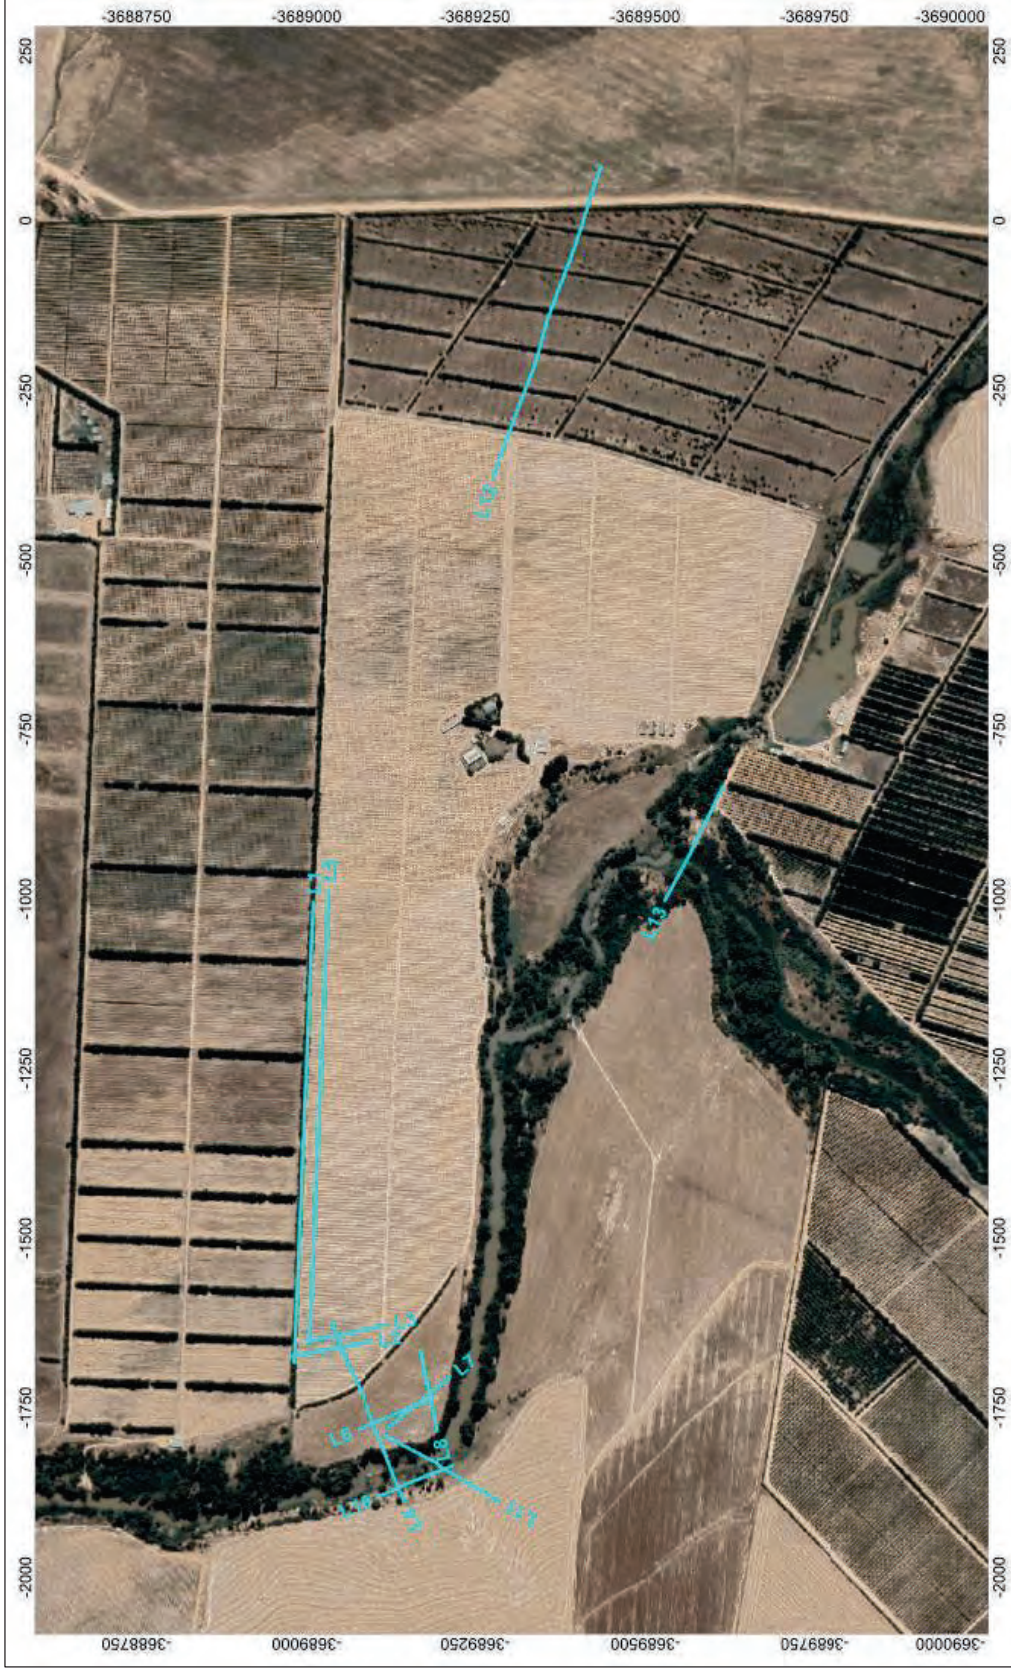
Figure 12: Electrical Resistivity Imaging

Electrical Resistivity Imaging is a method to measure the electrical resistivity of soils and rocks with increasing depth. Electrical resistivity profiling is particularly useful in providing an indication of the depth of weathering or depth to bedrock, as well as providing information on the presence of features such as faults/shear zones and intrusive dykes. The electrical resistivity was carried out at the proposed weir position, wing walls, along the embankment dam and saddle dam as well as the river crossing. A total of 12 electrical resistivity imaging traverses were surveyed amounting to a length of 3070 m.

The position of the electrical resistivity and seismic investigation carried out at on site is given below in Figure 12 and Figure 13 respectively. The results of the geophysical surveys are included in the reports presented as Annexure F. The investigation points for the soil corrosivity survey are indicated in Figure 14 below and the results of the survey is included as Annexure G to this report

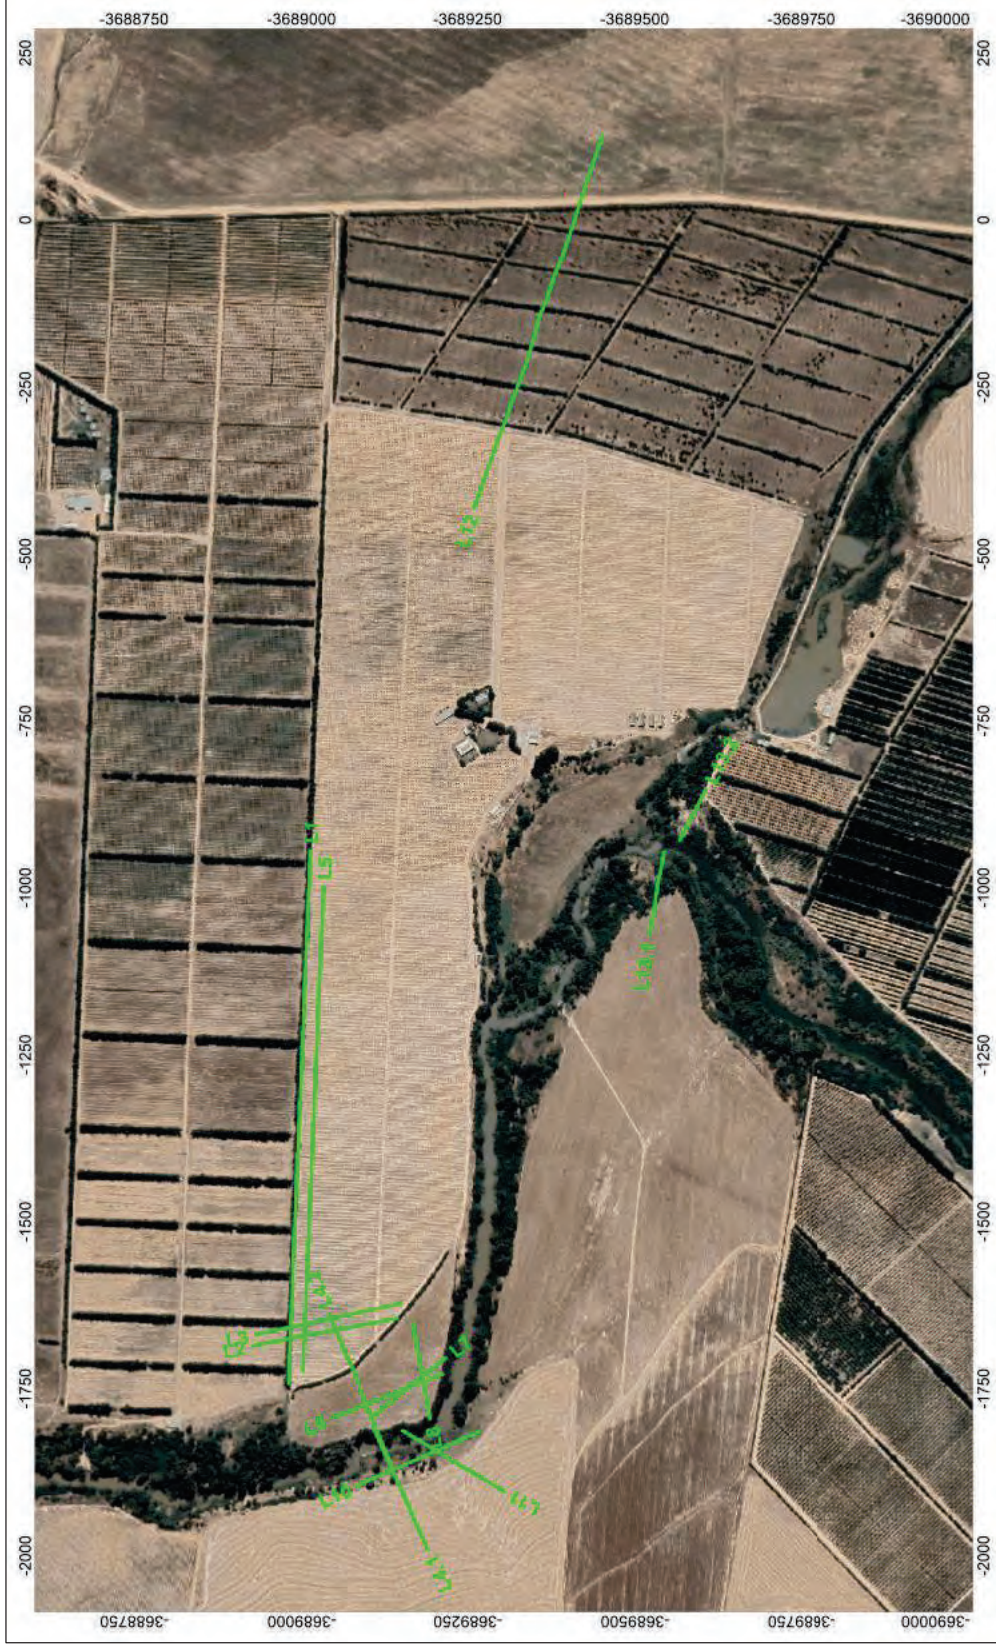
Figure 13: Seismic Refraction Survey

Seismic refraction is a method to measure the velocity of compressional waves (P-waves) of soils and rocks with increasing depth. Seismic refraction survey is required to determine the depth of weathering and depth to bedrock. The seismic refraction survey was carried out at the proposed weir position, wing wall, along the embankment dam and saddle dam as well as at the river crossing. Due to the heavy rains that occurred just before the time of the investigation, the river crossing area was inundated and therefore the seismic lines were posing difficulty in-terms of placing the geophones. It was therefore suggested that the survey be carried out on the banks of the river and not across the high flowing river. A total of 14 seismic refraction traverses were surveyed amounting to a length of 4141 m.

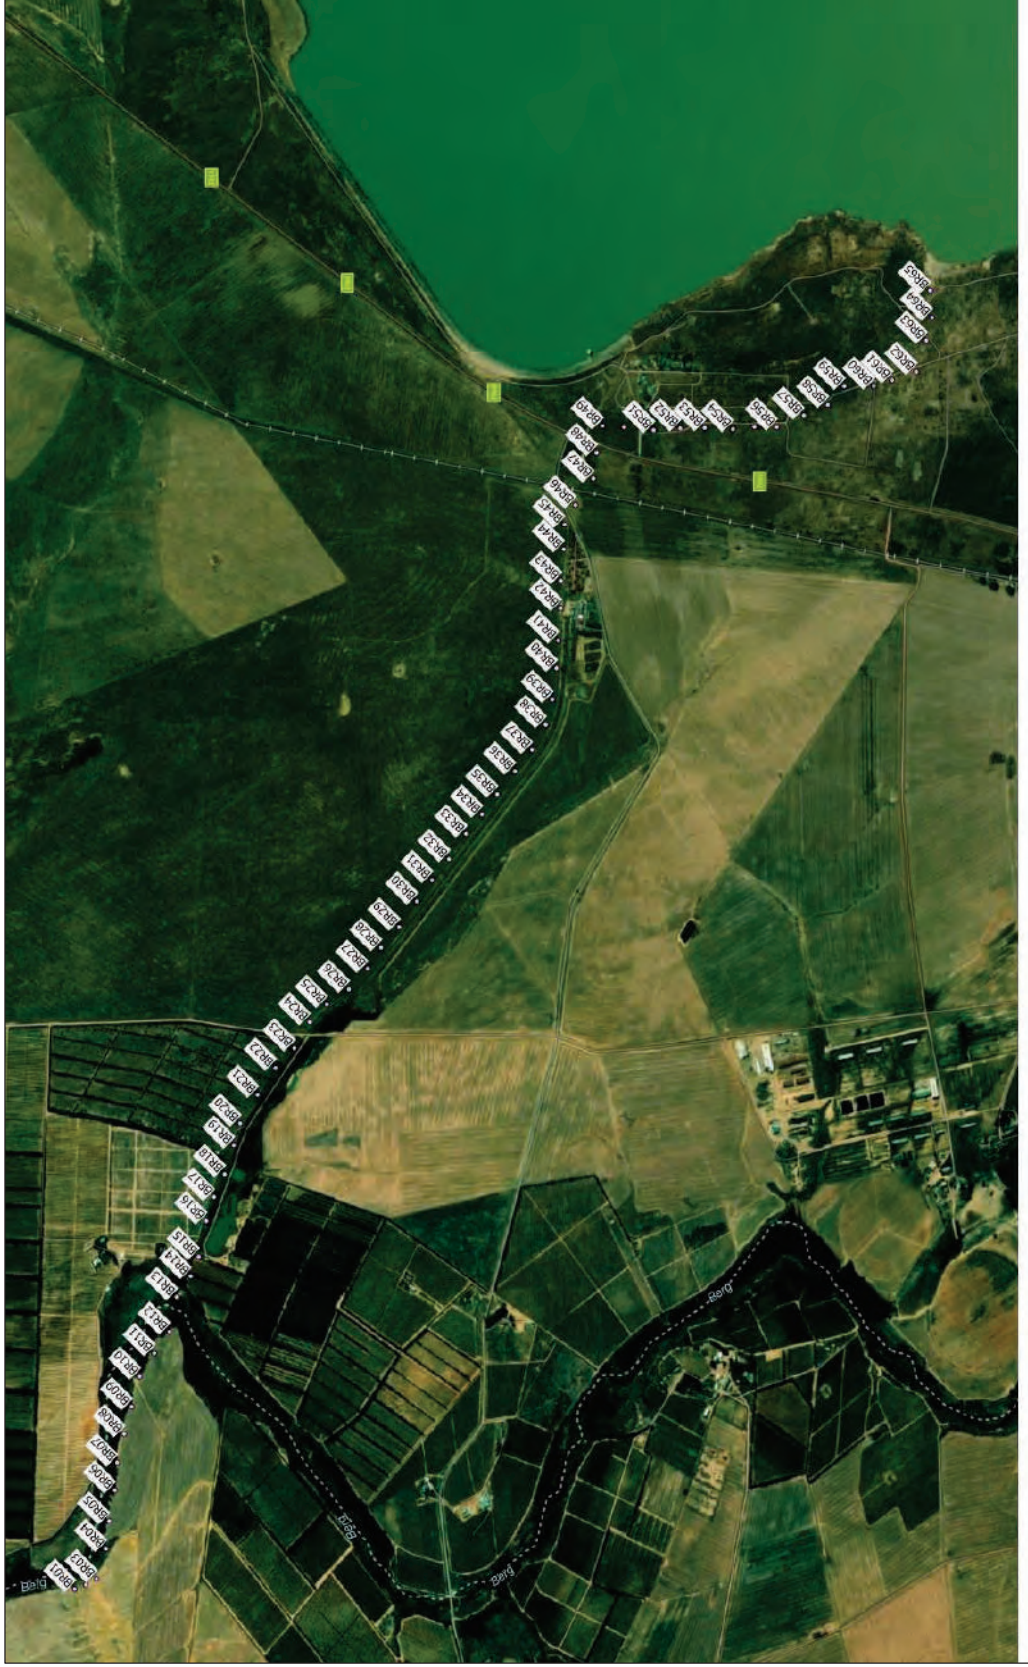
Figure 14: Soil Resistivity Survey Points

Soil Resistivity Surveys/Soil Corrosivity Surveys were carried out along the pipeline route. This included a detailed soil resistivity survey undertaken at nominal intervals of 100 m, using the 4-pin Wenner method. A deep soil resistivity survey at the crossing of the pipeline with the high voltage power line(s) and soil sampling and analysis for chemical and bacterial (i.e., Sulphate Reducing Bacteria) activities at nominal intervals of 1000 m. Soil acts as the electrolyte in the electrochemical corrosion cell formed during the external electrochemical corrosion of a pipeline. Soil resistivity is an electrical characteristic of the soil (and groundwater) which affects the ability of corrosion currents to flow through the electrolyte. Soil resistivity is a function of soil moisture and the concentrations of ionic soluble salts and is the most comprehensive indicator of a soil's corrosivity.
